RESIDENTIAL INSPECTION REPORT

1234 Main Street
Houston TX 77099

I. STRUCTURAL SYSTEMS

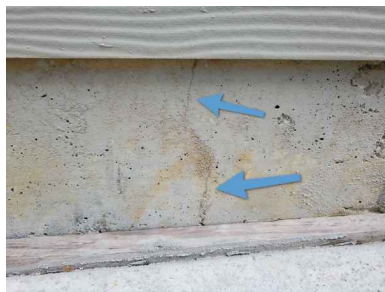
Right Side

1: Foundation Cracks - Minor

Minor cracking was noted at the foundation. These did not appear to be structural in nature. These are common as concrete ages, shrinkage surface cracks are normal.

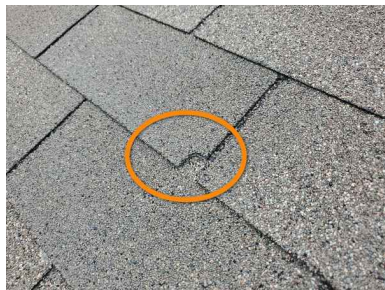
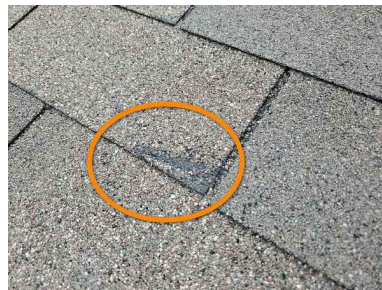
1: Shingles: Damaged/Torn/Missing

Multiple Locations

Roof shingle material was missing, damaged, or torn in areas. Evaluation and/or repair by a qualified roofing professional is recommended.

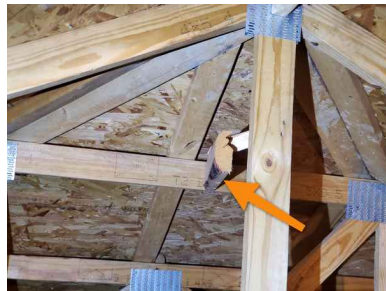
1: Framing: Cracked/Damaged Framing Members

Cracked or damaged framing members were observed. Evaluation by a qualified contractor is recommended.

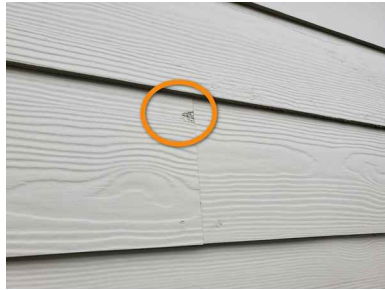
Left Side (Damaged)

3: Exterior Walls: The exterior wall coverings, such as siding, trim fascia, soffit or eave had defects. Examples include, but are not limited to:

Damage -

Evaluation and remediation is recommended.

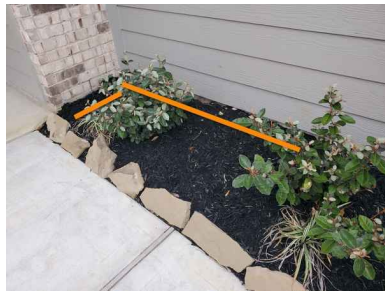
Front

4: Exterior: High Soil

A high soil level was observed. The foundation should have at least 4 inches of exposure. Evaluation and remediation is recommended.

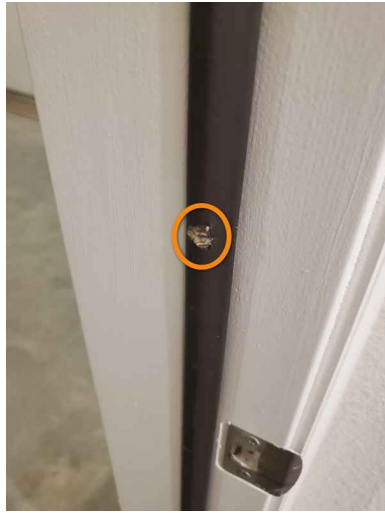
Garage Door

1: Doors: Weatherstripping Missing or Damaged

Door was missing or damaged standard weather-stripping. This can result in significant energy loss and moisture intrusion. Evaluation and remediation is recommended.

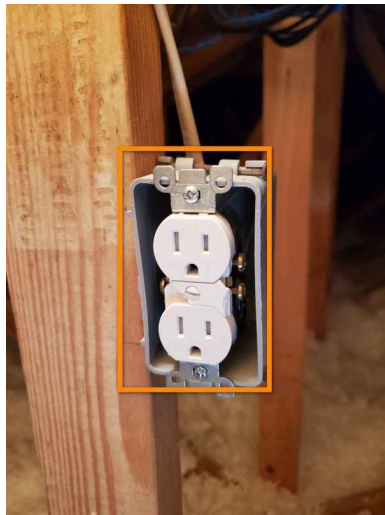
In Attic

1: Receptacle/Switch Covers: Missing, Loose or Damaged

One or more receptacle/switch cover plates were missing, loose or damaged. Replacement of cover plates is recommended for safety. Evaluation and remediation by a qualified electrical contractor is recommended.

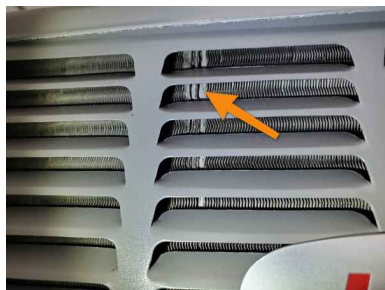
(Damaged)

1: Condenser: Damaged/Dirty Fins

External fins on the condensing unit were damaged or dirty. Evaluation and remediation by a licensed HVAC contractor is recommended.

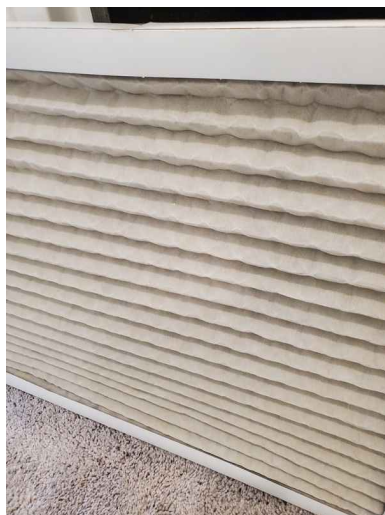
1: Filters: Require Replacement or Missing

The furnace filters may have been beyond their expected lifespan or were missing. In addition, inspector cannot determine what effect this has on the temperature readings. Replacement is recommended.

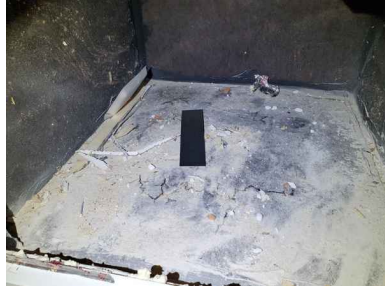
2: Return Air System: Dust/Debris In/On Chase

Dust particles can clog cooling coils and may lead to coil corrosion over time. Proper cleaning and evaluation of the return air shaft, ducts, and coils is recommended.

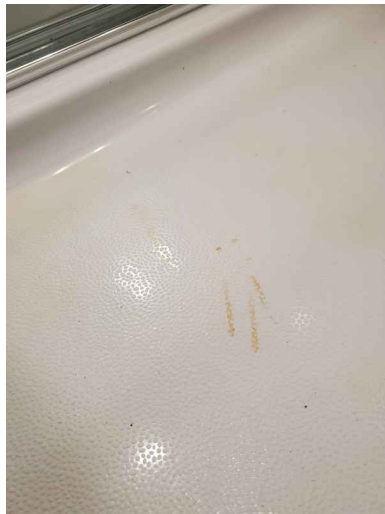
Primary Bathroom

1: Shower/Tub: Surface Defects

Defects were observed on the shower/tub surface. Evaluation and remediation is recommended.

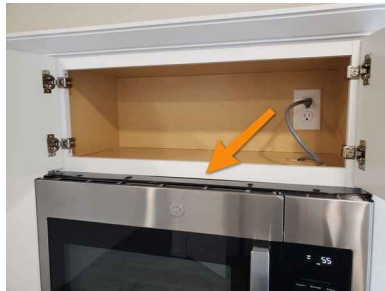
Not Recirculating Property

1: Recirculating: Not Efficiently Recirculating

Evaluation and remediation is recommended.

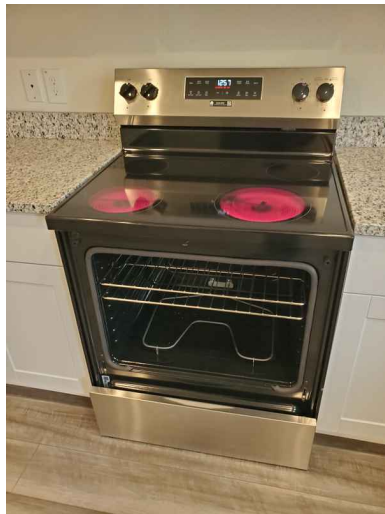
Oven Functionality Not Tested :
Missing Door.
